Manhole Inspection Summary

Manhole # S45G2_002MH

Printed On: 10/15/2008

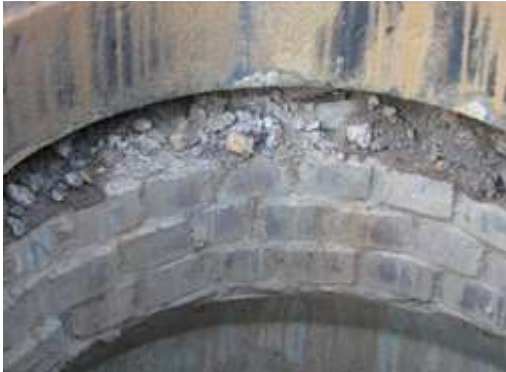
Defect 2

Condition: ☐ Sound ☐ Cracked ☐ Root Intrusion ☒ **Loose Brick** ☐ Deteriorated

Infiltration: ☐ None ☐ Joint ☐ Cracks ☐ Mortar ☐ Roots ☒ **Wall**

Chimney

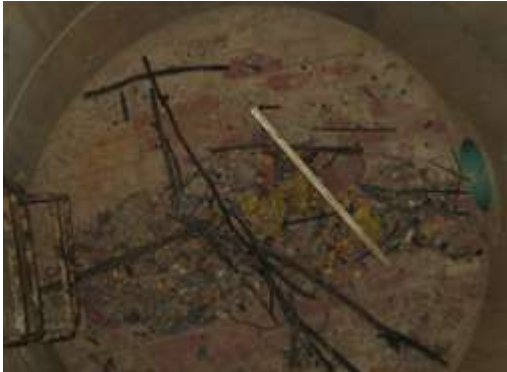
Defect 1

Debris

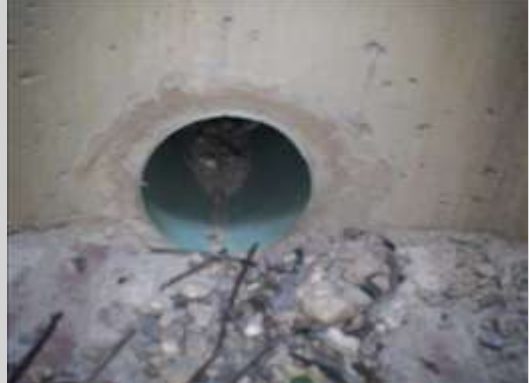
12 O'Clock Outflow

8 in. Circular Gravity Sewer
Pipe Out @ 12 O'Clock
